Steel City National Bank  
Chicago Heights, Cook County  
ILD 005246590  
IEPA 0310450024

25 September 1998

## CERCLA Report

**Illinois Environmental  
Protection Agency**

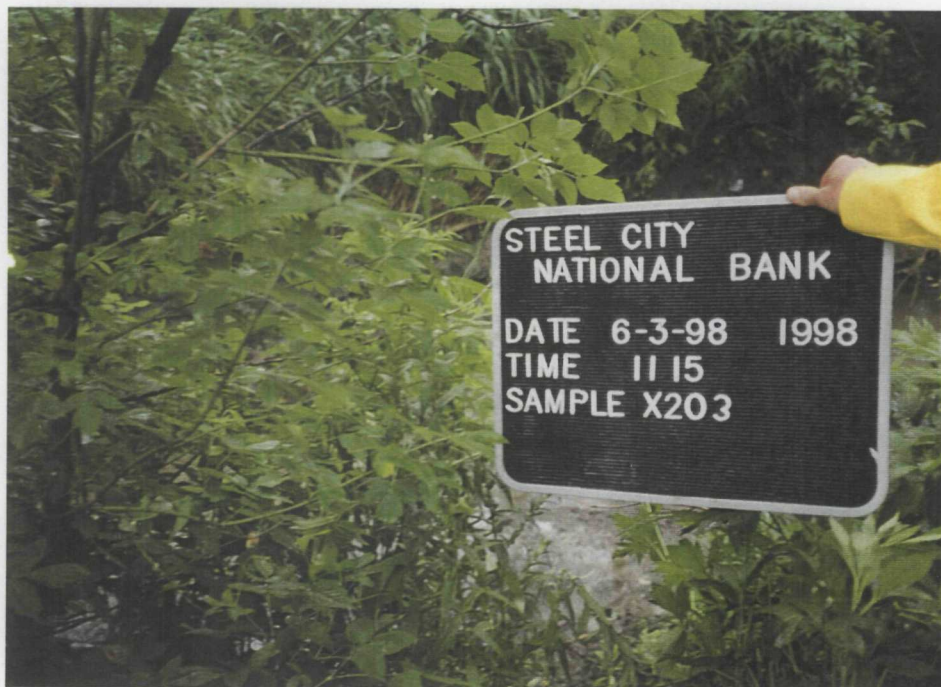
<b>DATE:</b> 6/3/98
<b>TIME:</b> 1115
<b>PHOTO BY:</b> Ted Prescott
<b>ROLL / PHOTO:</b> photo 2
<b>SAMPLE:</b> X203
<b>DIRECTION:</b> N
<b>COMMENTS:</b> Photo taken toward
east along west bank of Third
Creek at intersection of creek &
north drainage ditch.

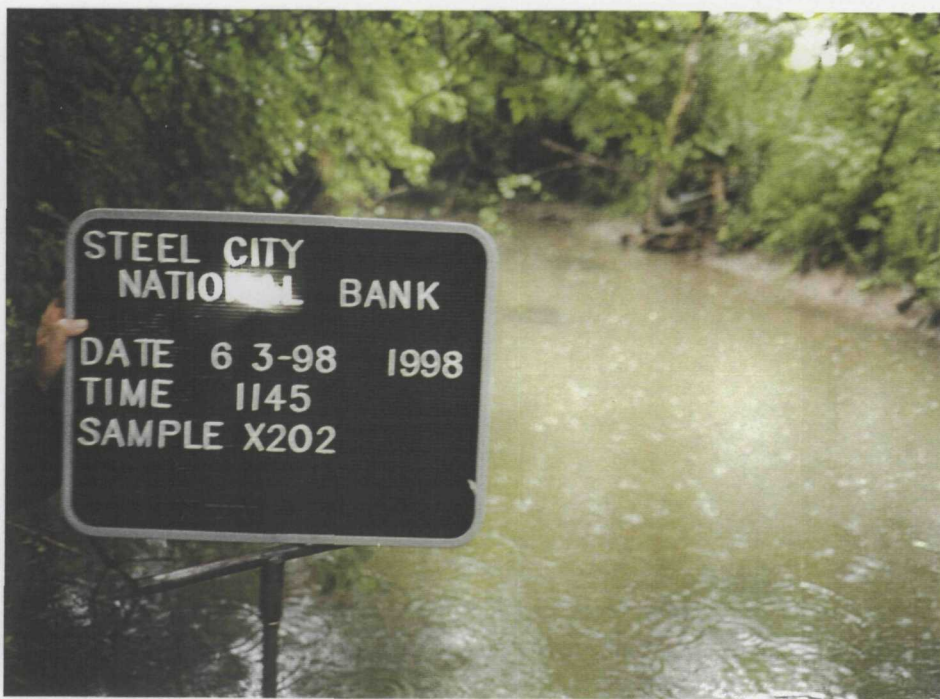
**COMMENTS:** Photo taken toward  
northeast at Third Creek & south  
drainage ditch.

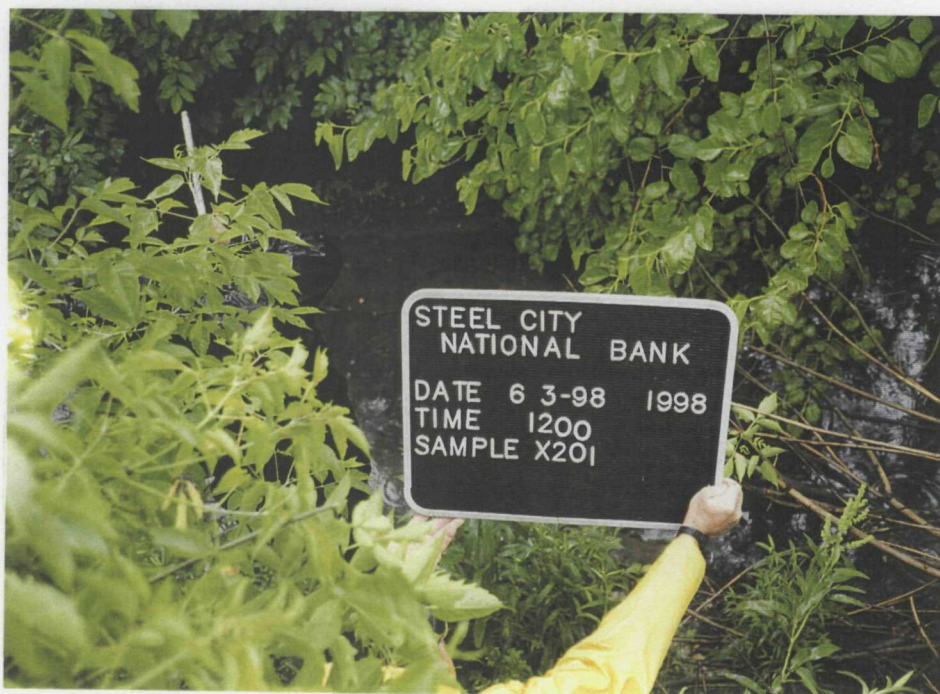
**COMMENTS:** Photo taken toward  
upstream portion of Third Creek.

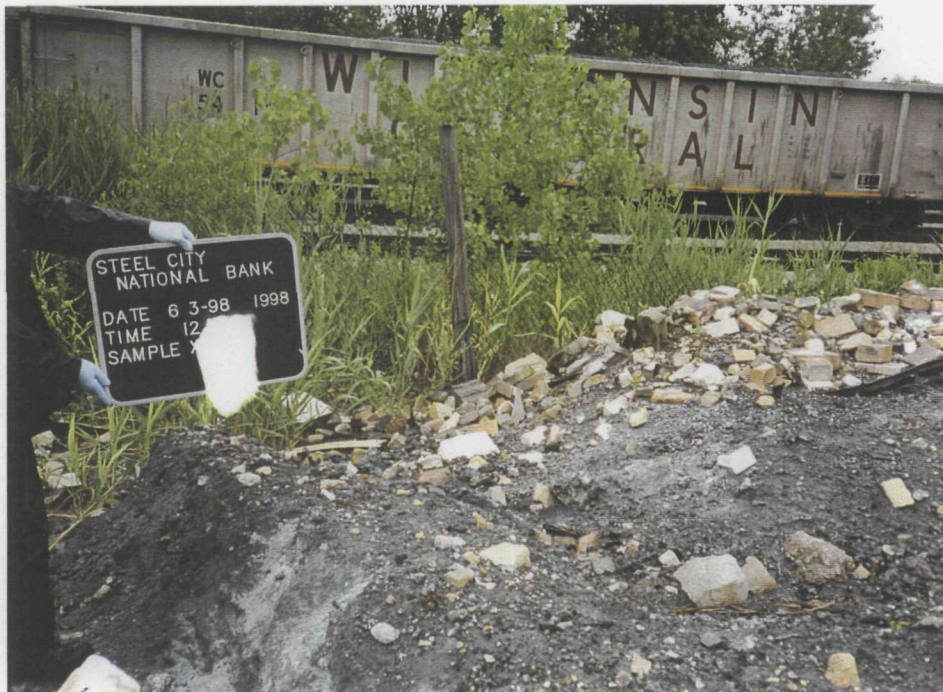
were present (284,000 ppm). Sediment sample location X205, located at the quench water discharge point along the north drainage ditch, contained contaminant levels for cadmium, chromium, copper, lead, manganese, nickel and zinc at concentrations significantly higher than 3X the background levels. Sediment sample X206 located at the lagoon discharge point had copper concentrations above background levels. No contaminants were found in the downstream sediment sample.

**COMMENTS:** Photo taken toward  
north showing lime-lined quench  
water drainage ditch.

**NOTE:** light blue colored material  
on side of ditch.

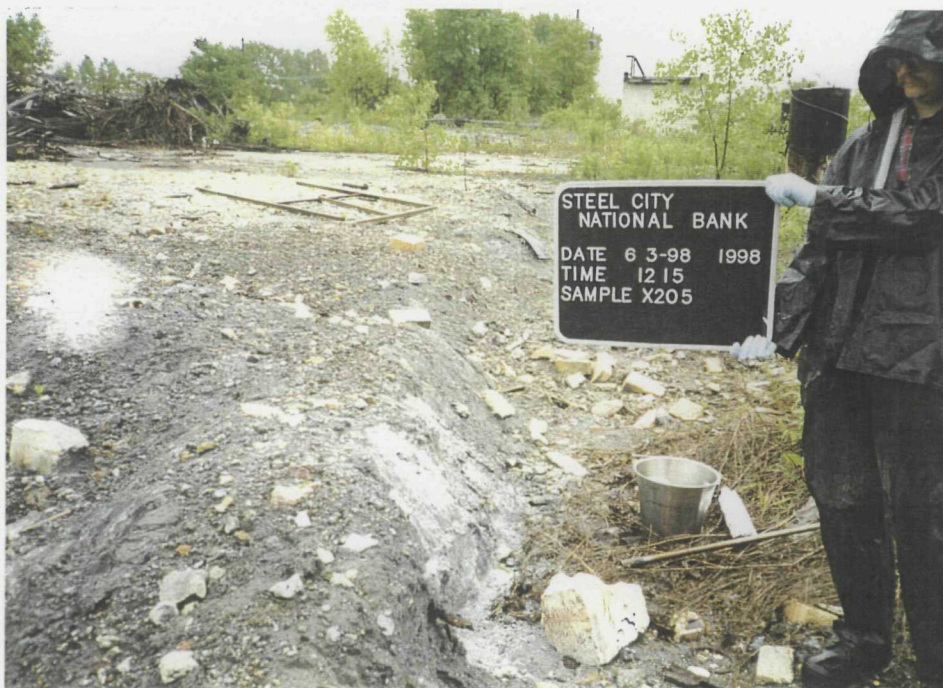
**COMMENTS:** Photo taken toward  
center of site.

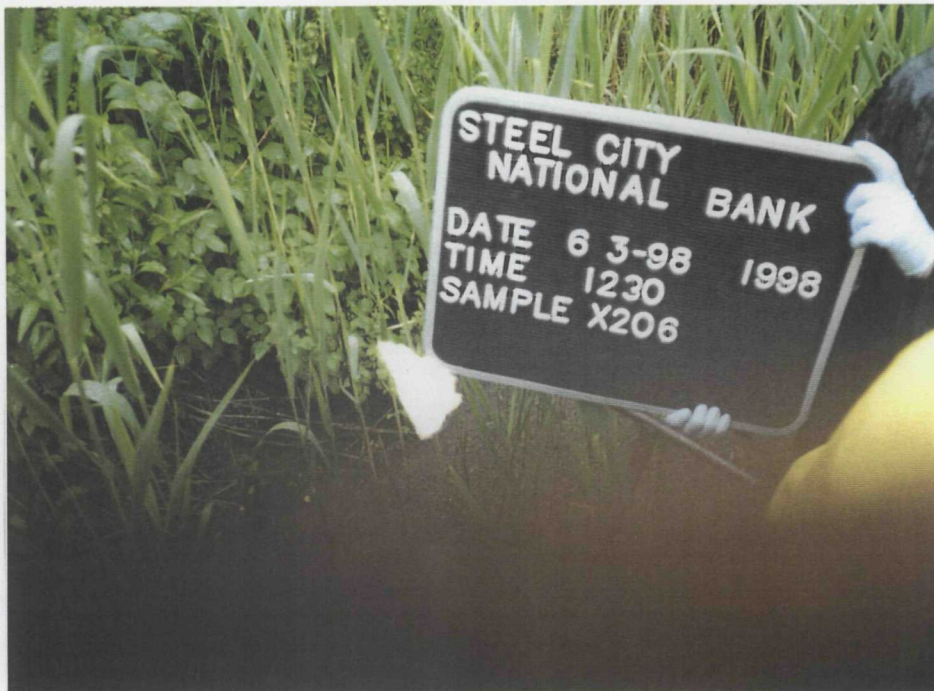
<b>DATE:</b> 6/3/98
<b>TIME:</b> 1230
<b>PHOTO BY:</b> Ted Prescott
<b>ROLL / PHOTO :</b> photo 6
<b>SAMPLE:</b> X206
<b>DIRECTION:</b> N
<b>COMMENTS:</b> Photo taken toward north into west edge of wetland.

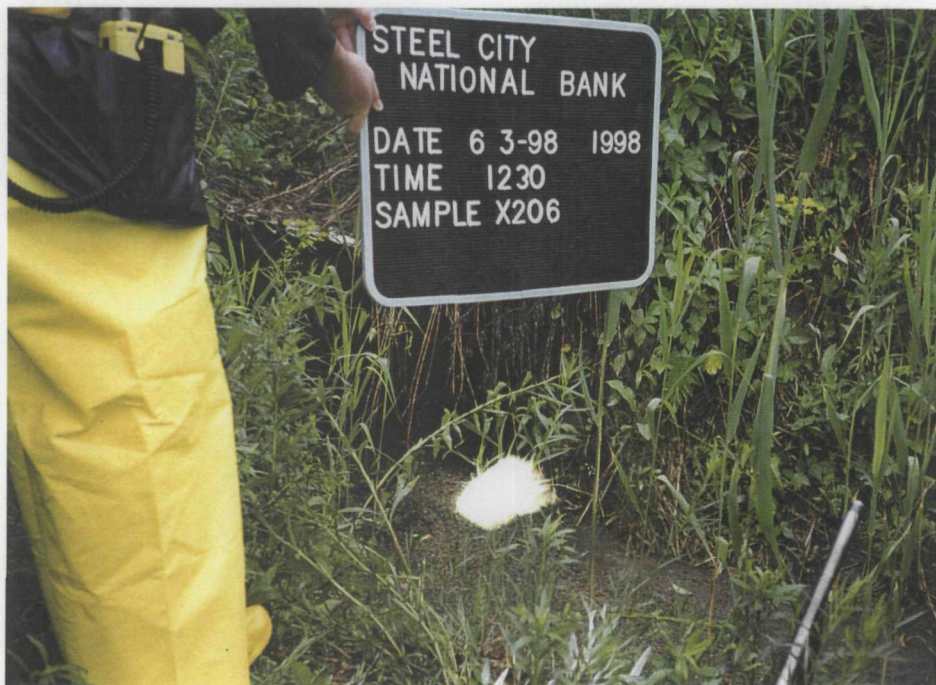
<b>DATE:</b> 6/3/98
<b>TIME:</b> 1230
<b>PHOTO BY:</b> Ted Prescott
<b>ROLL / PHOTO:</b> photo 7
<b>SAMPLE:</b> X206
<b>DIRECTION:</b> W
<b>COMMENTS:</b> Photo taken toward the discharge point of the lagoon.

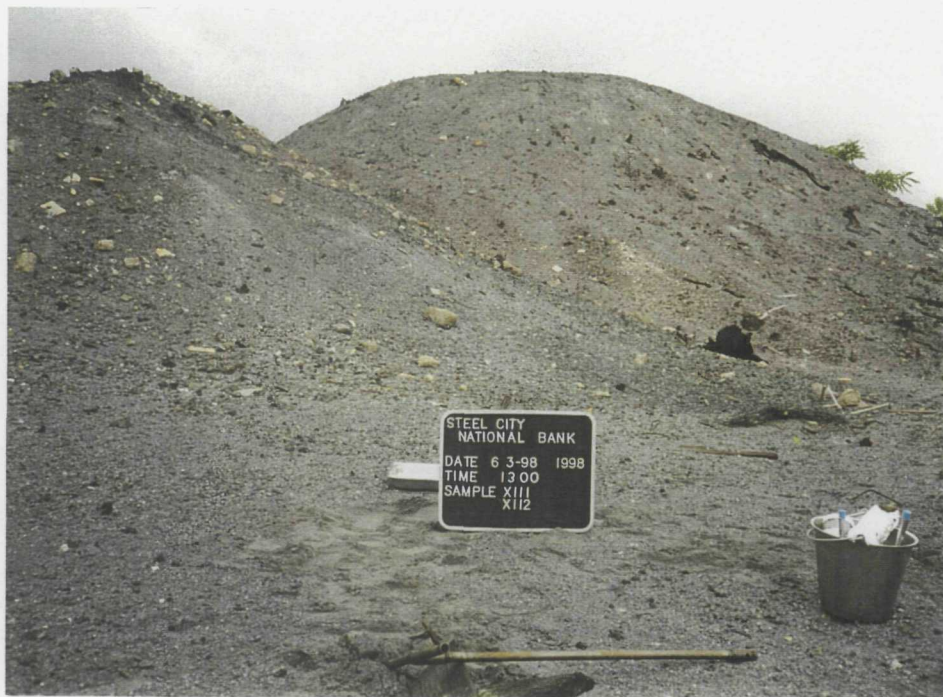
**COMMENTS:** Photo taken toward  
center of main waste pile.

**NOTE:** composition & material  
in pile.

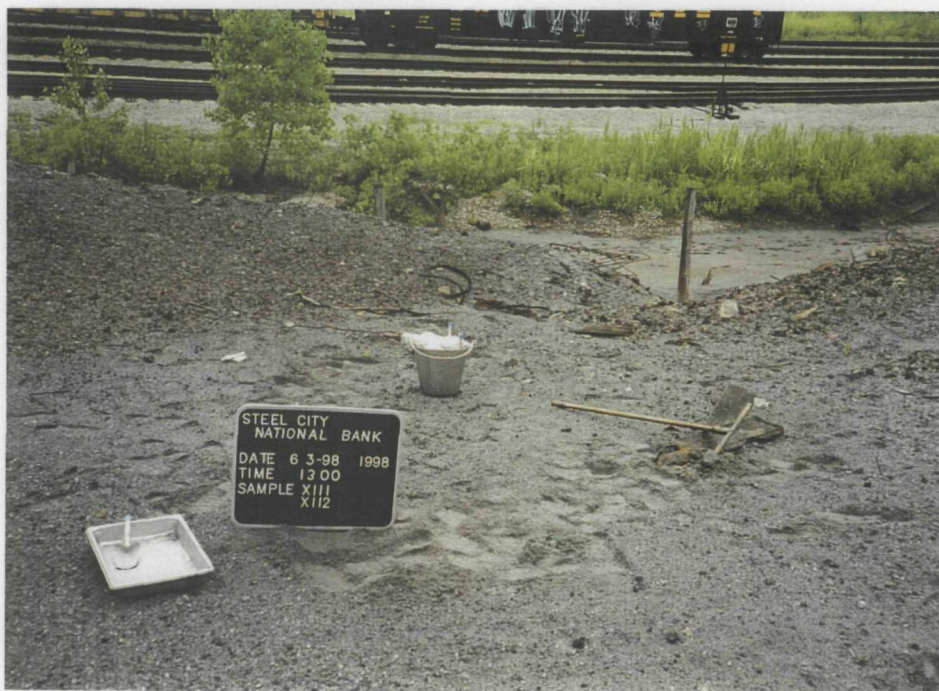
**COMMENTS:** Photo taken toward  
drainage area into north drainage  
Ditch.

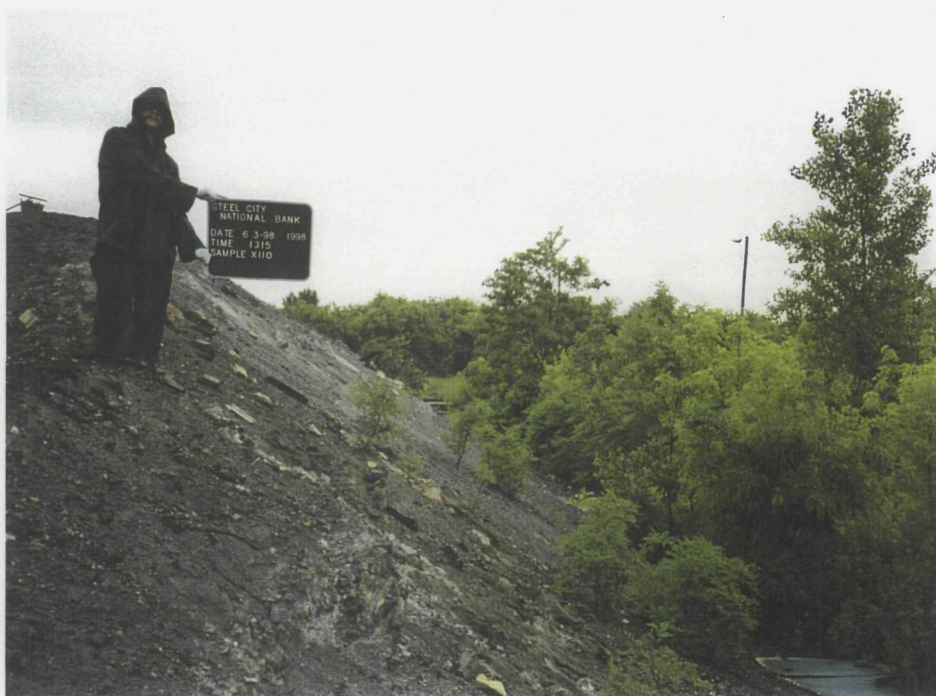
**COMMENTS:** Photo taken along  
east side of main waste pile.

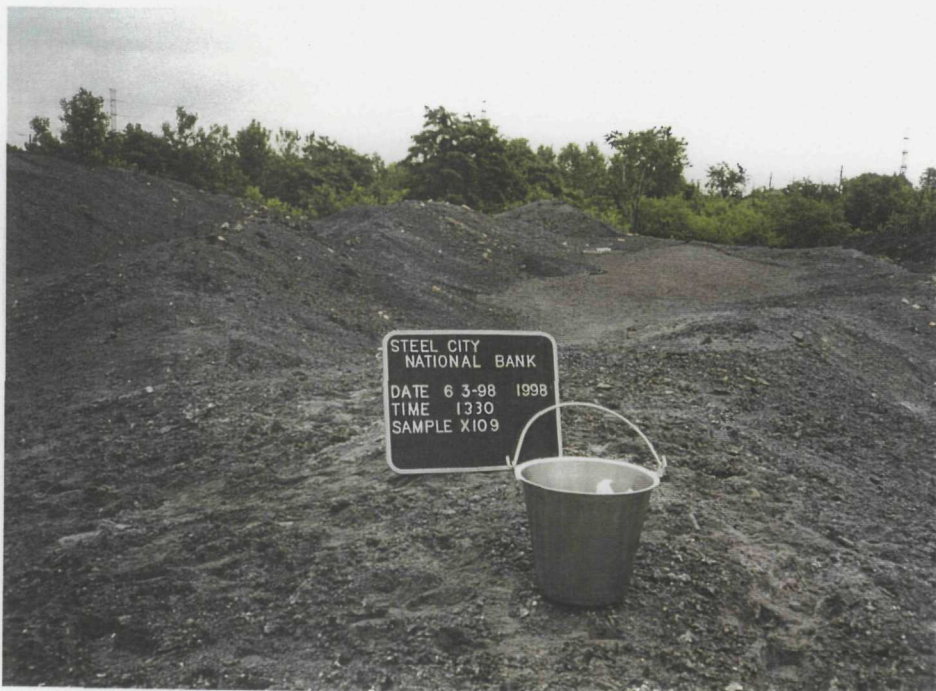
**COMMENTS:** along top of  
main waste pile.

**NOTE:** discoloration in materials.

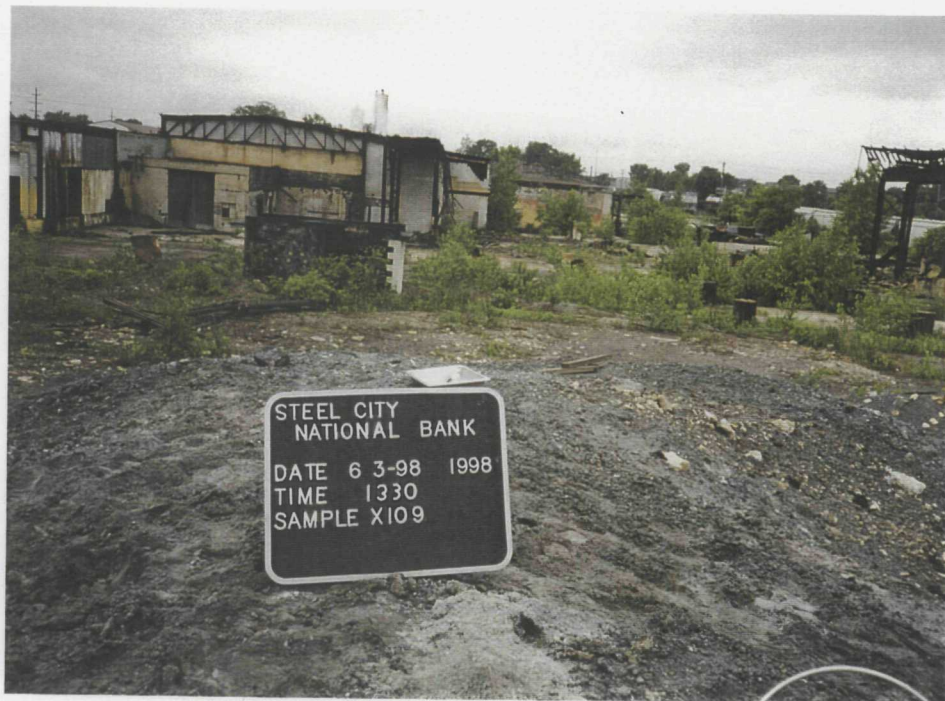
**COMMENTS:** Photo taken toward  
the main facility & plant.

**NOTE:** structures to right were  
the main reclamation plant.

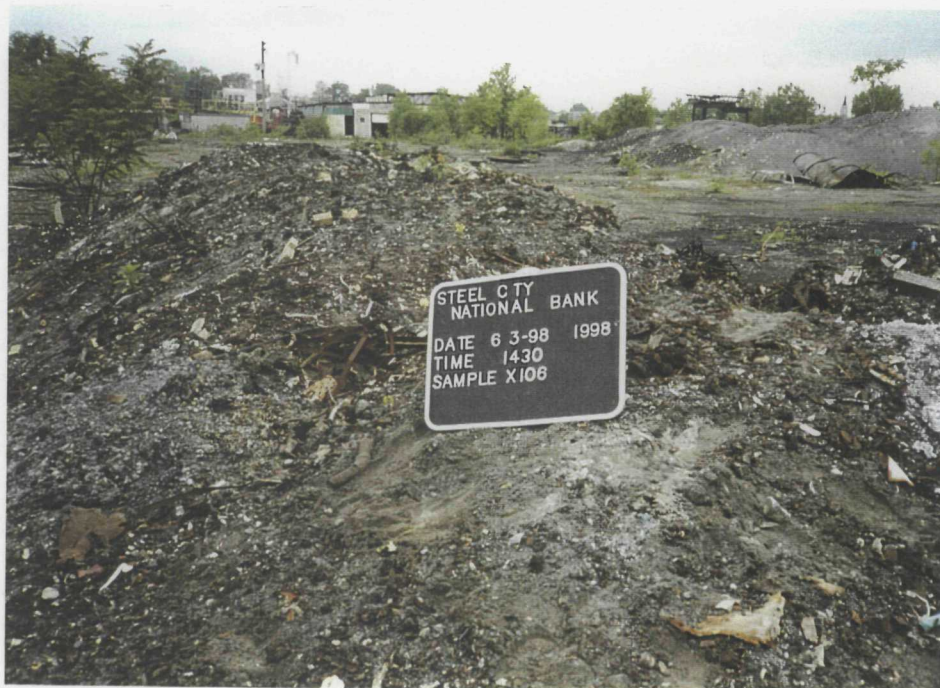
**COMMENTS:** Photo taken toward  
main facility from second waste  
pile.

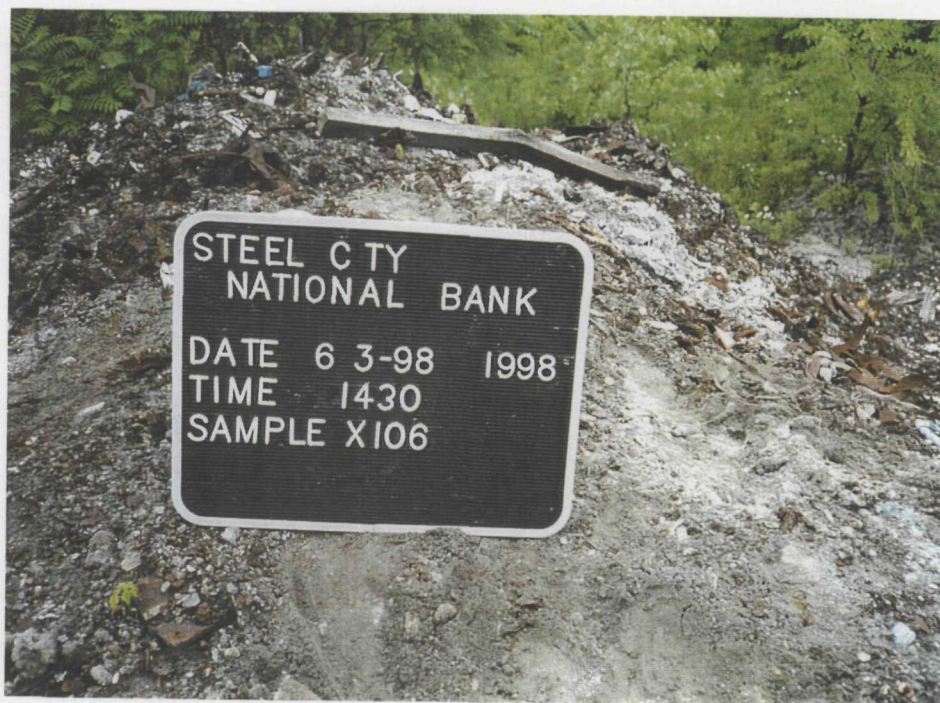
**COMMENTS:** Taken from top of  
second waste pile.

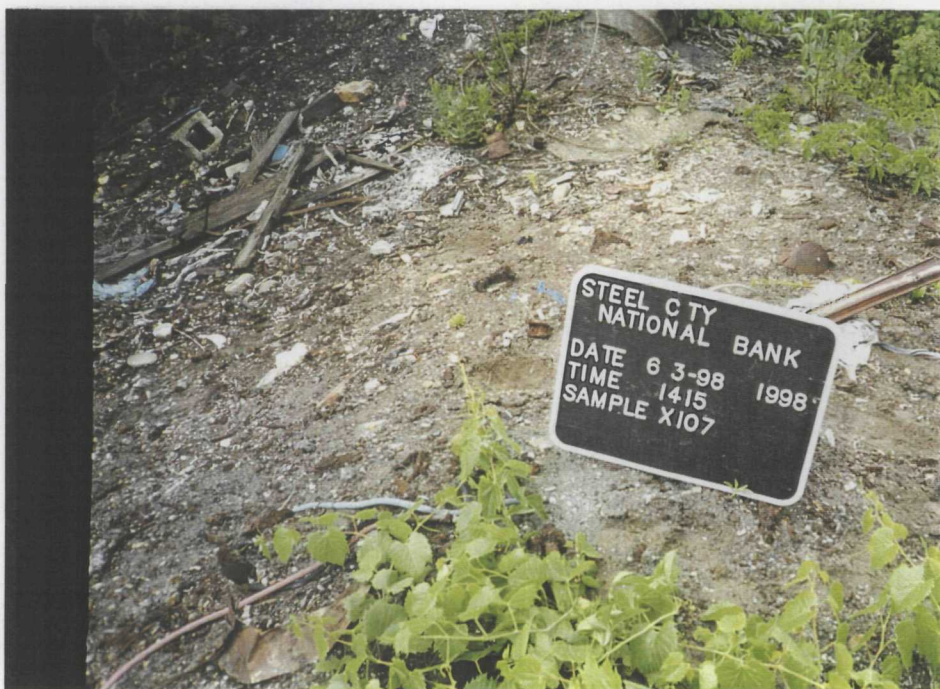
**COMMENTS:** taken from the  
east side of the second waste pile.

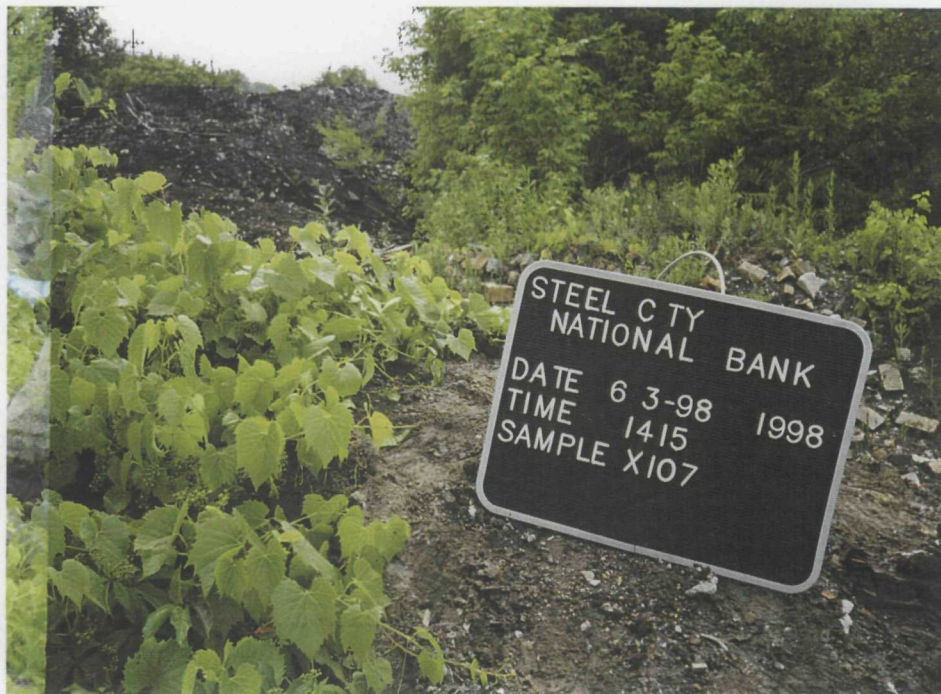
**COMMENTS:** Photo taken along  
east side of second waste pile.

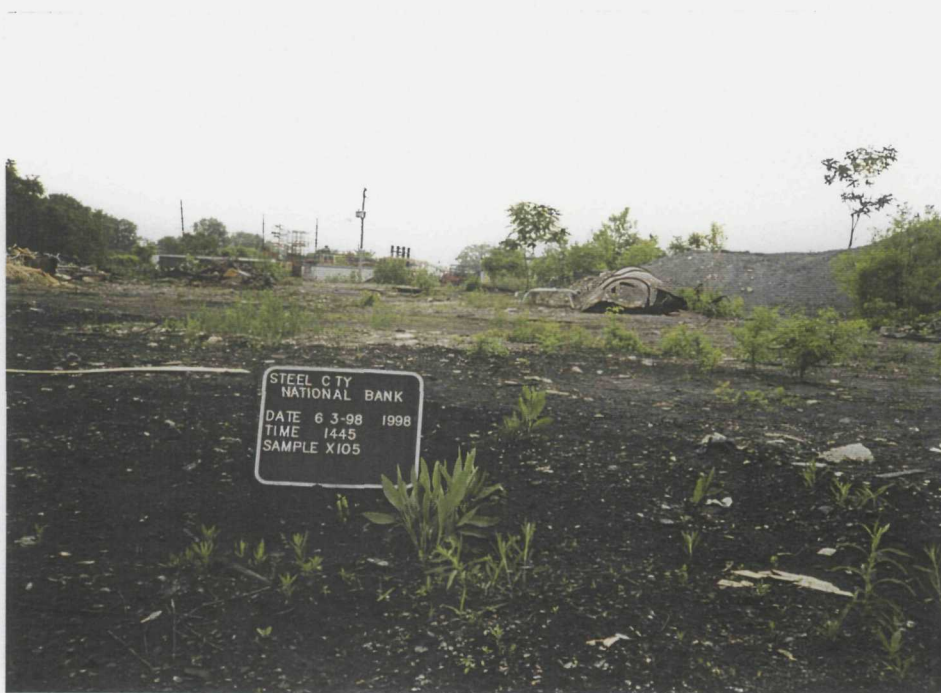
**COMMENTS:** Photo taken toward  
main facility from north of  
second waste pile.

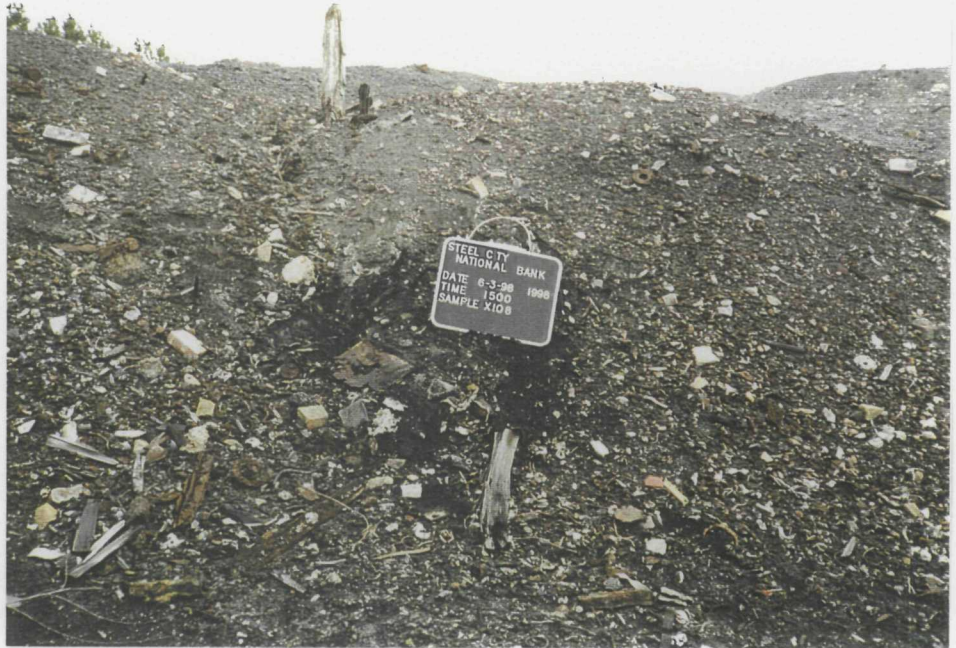
**COMMENTS:** Photo taken toward  
main waste pile - of asphalt like  
material piled adjacent to main  
pile.

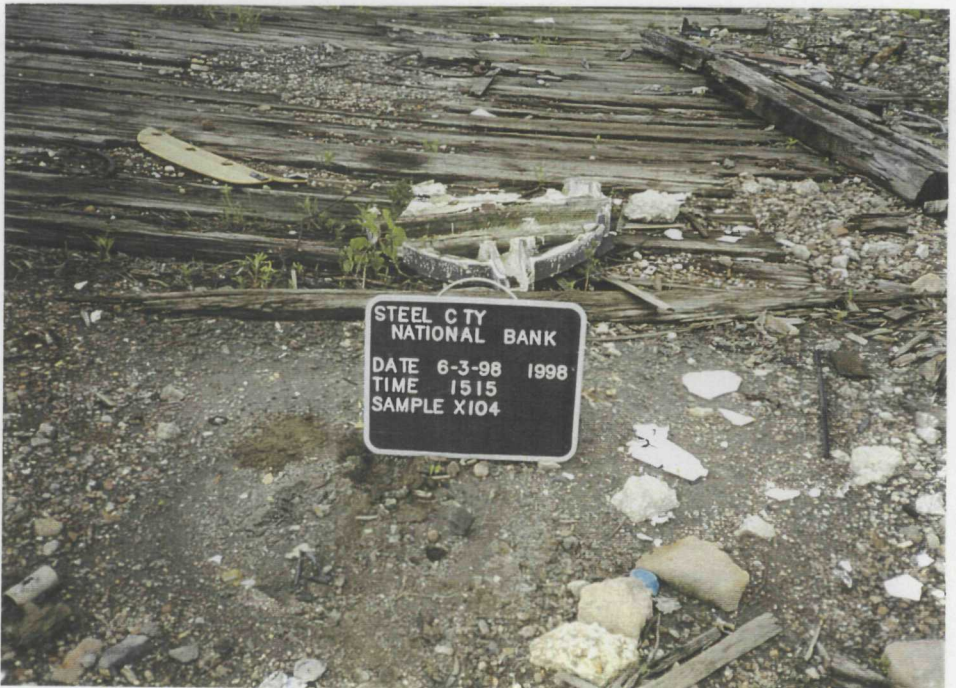
**COMMENTS:** Photo taken toward  
wooden foundation of former  
building.

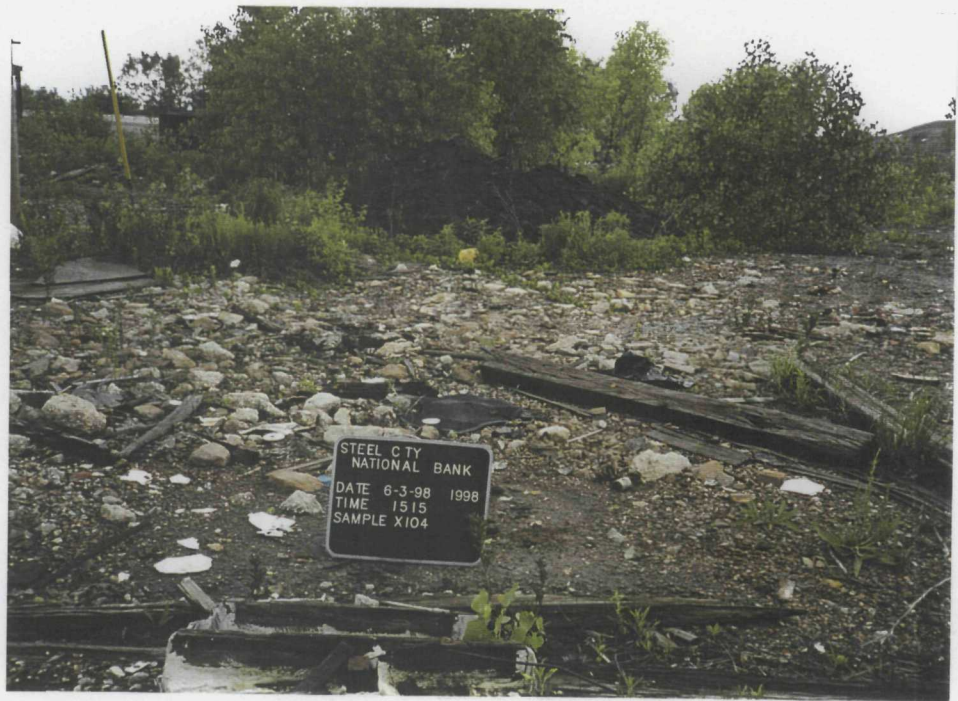
**COMMENTS:** Photo taken toward  
State Street.

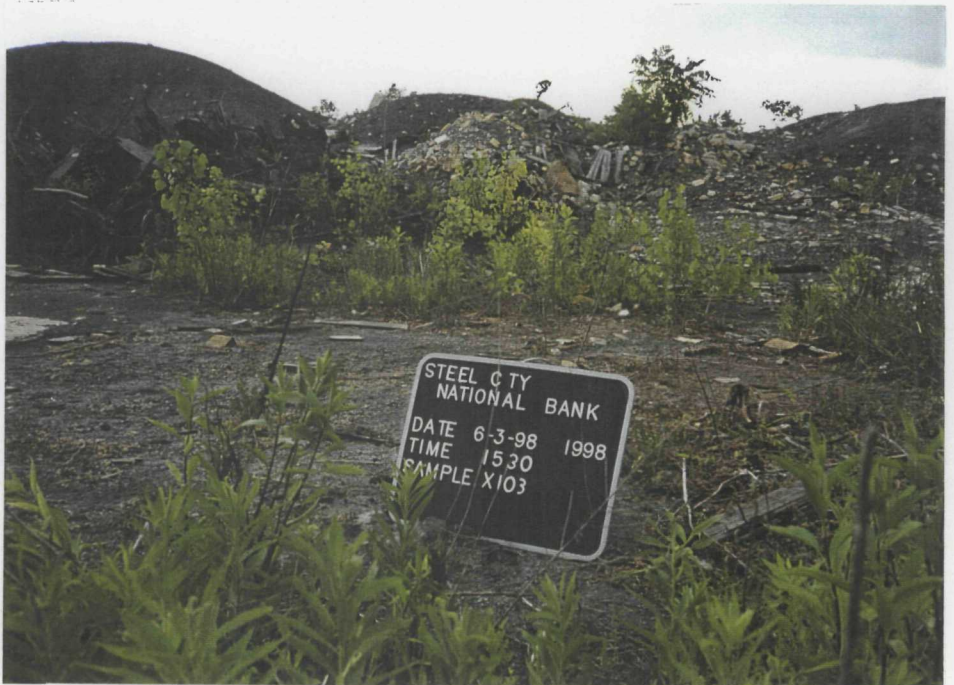
**COMMENTS:** Photo taken toward  
main waste pile.

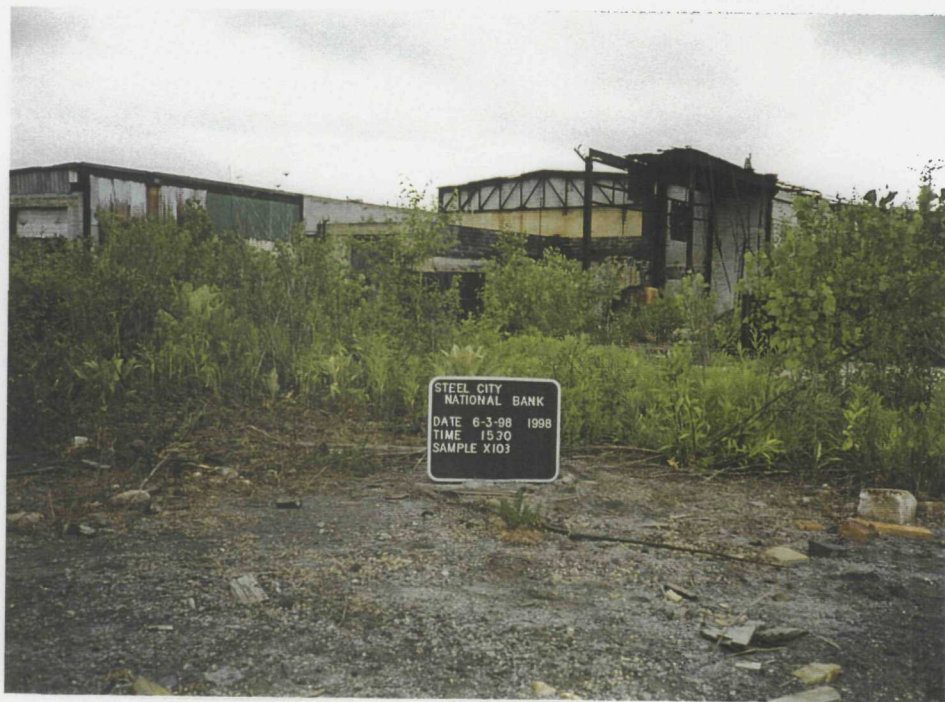
**COMMENTS:** Photo taken toward  
main facility buildings.

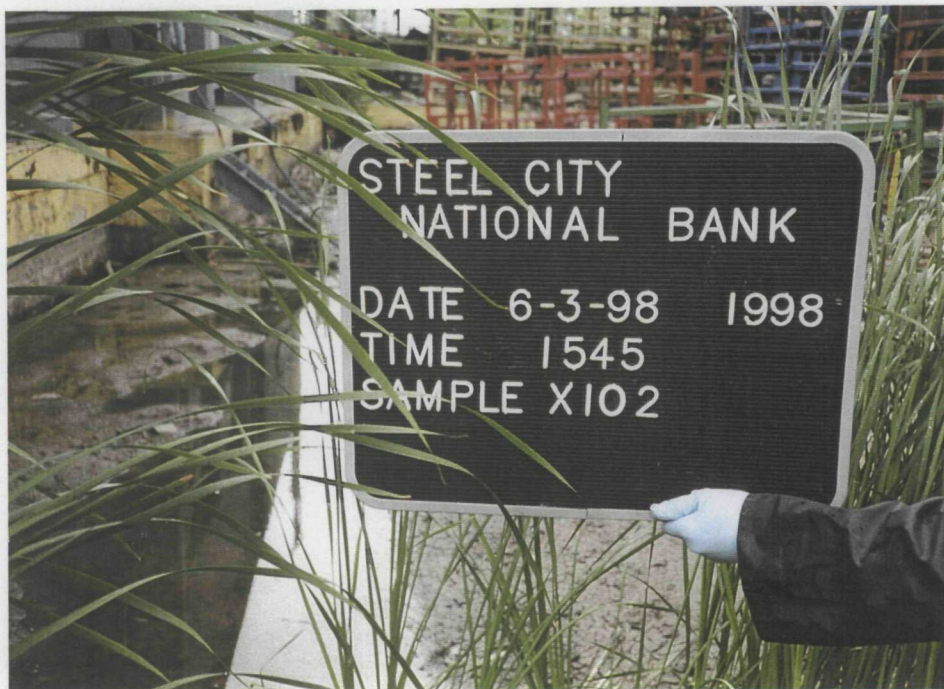
**COMMENTS:** Photo taken  
between offices & main building.
